Manhole Inspection Summary

Manhole # S15II_010MH

Insp Date: **10/29/07 10:14 AM**

Location Address: **1700 BRADDISH**

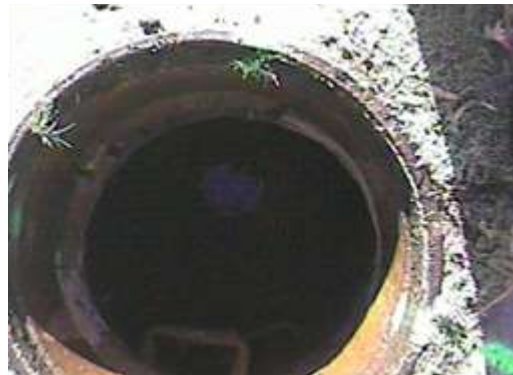
Defect 2

Count: **5** Missing: **0** ☒ **Corroded**

CORRODED STEPS

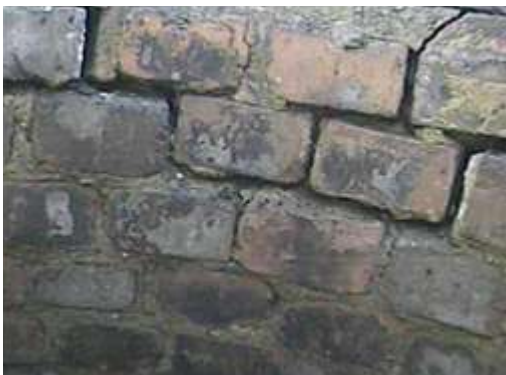
Defect 1

Condition: ☐ Sound ☒ **Cracked** ☐ Root Intrusion ☐ Loose Brick ☐ Deteriorated

CRACKED CORBEL

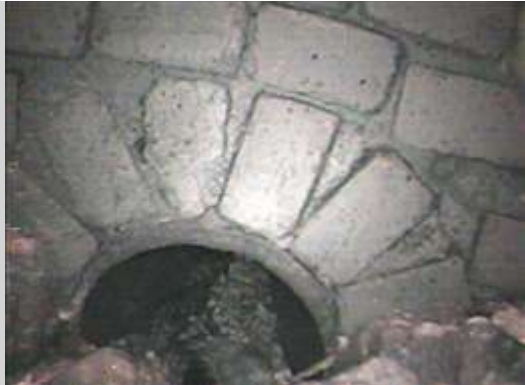
12 O'Clock Outflow

8 in. Circular Gravity Sewer
Pipe Out @ 12 O'Clock

Pipe Height: (in.) Direct
Pipe Material: **Clay** ☐ Pipe Lined
Invert Depth: **8.64** (ft.) Flow Characteristics: **Slow**
Deposits: ☐ None ☐ Mud ☒ Sludge ☒ Debris ☒ Grease
Silt Depth: **3** (in.) Deposits Extent: **Medium**
Infiltration: **None** Pipe Seal Cond: **Sound**

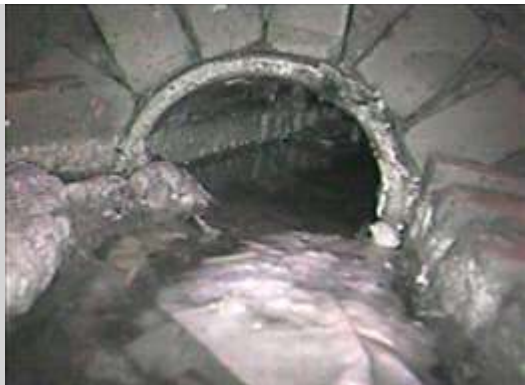
3 O'Clock Inflow

8 in. Circular Gravity Sewer
Pipe In @ 3 O'Clock

Pipe Height: (in.) Direct
Pipe Material: **Clay** ☐ Pipe Lined
Invert Depth: **8.69** (ft.) Flow Characteristics: **Slow**
Deposits: ☐ None ☐ Mud ☐ Sludge ☒ Debris ☒ Grease
Silt Depth: **2** (in.) Deposits Extent: **Light**
Infiltration: **None** Pipe Seal Cond: **Sound**

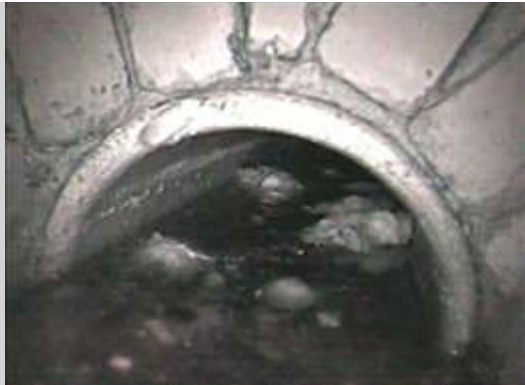
9 O'Clock Inflow

Deposits: ☐ None ☐ Mud ☐ Sludge ☒ **Debris** ☐ Grease

Silt Depth: **2** (in.) Deposits Extent: **Light**
